Convair *Traveler*

VOLUME XIX NUMBER 1 MAY/JUNE 1967

Delta P Filter Inspection

Care and Handling of Hose Assemblies

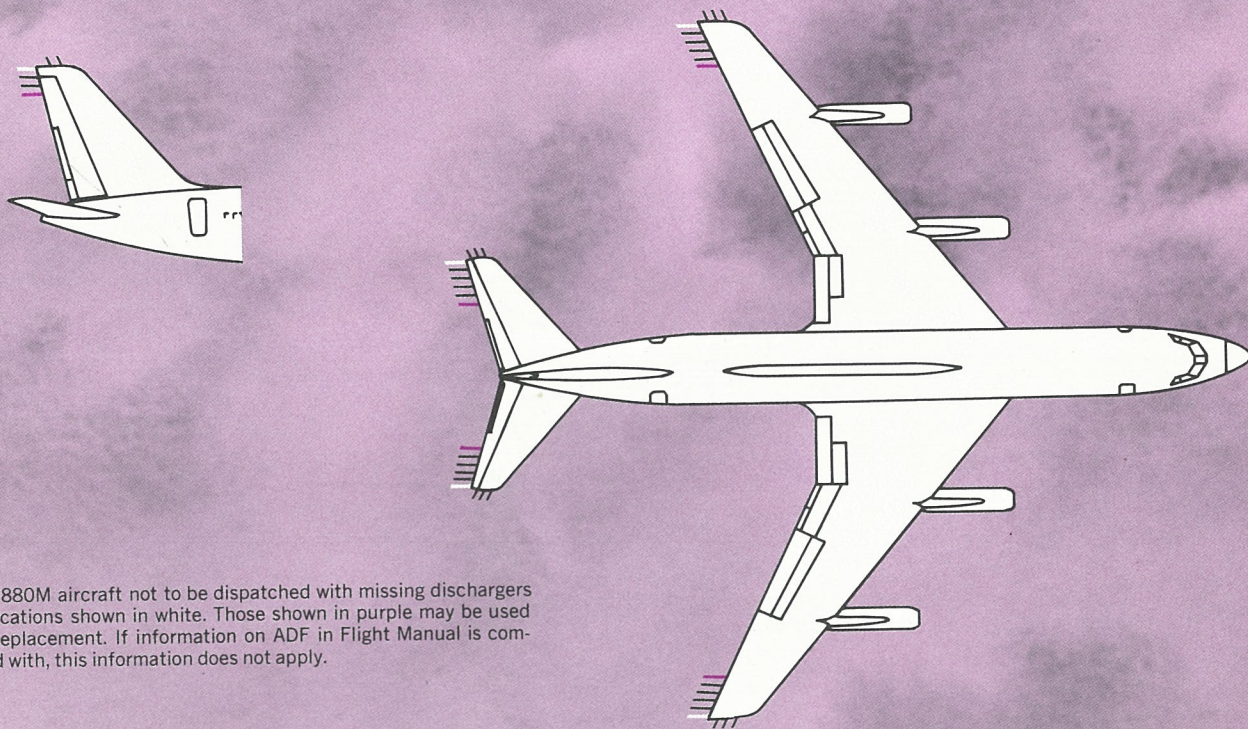
Figure 4. Allowable missing dischargers on 880/880M.

880/880M aircraft not to be dispatched with missing dischargers in locations shown in white. Those shown in purple may be used for replacement. If information on ADF in Flight Manual is complied with, this information does not apply.

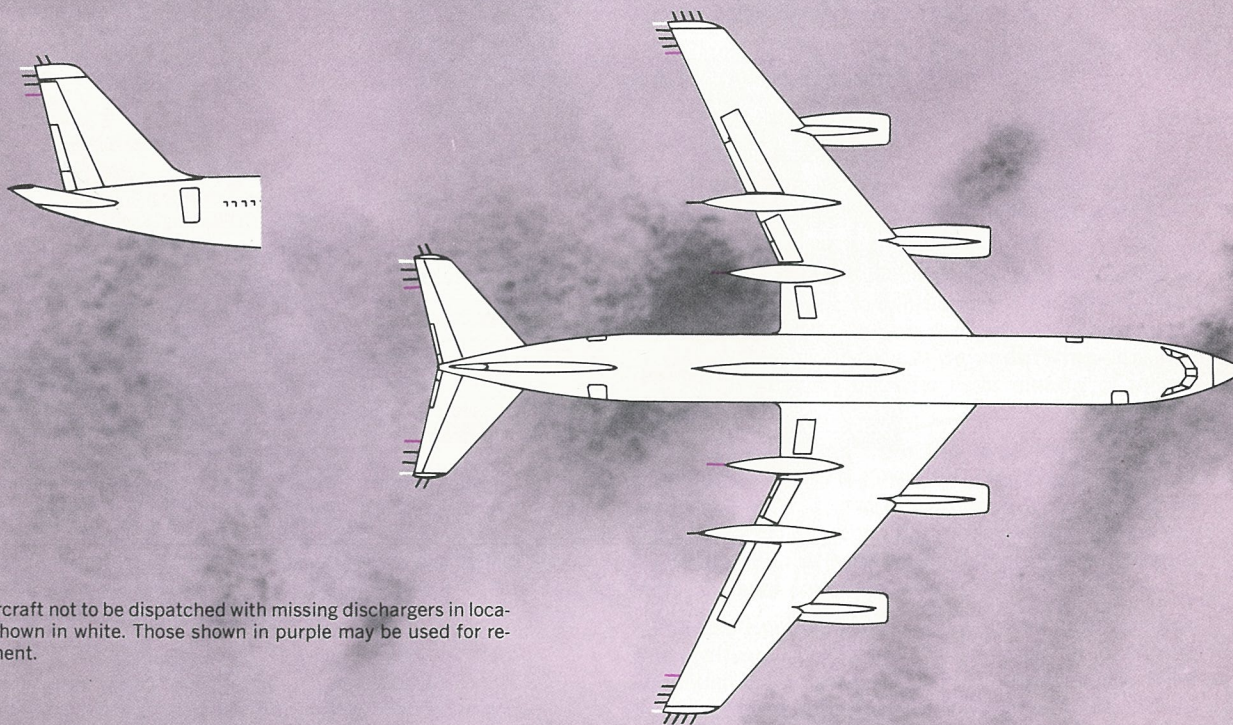
990 aircraft not to be dispatched with missing dischargers in locations shown in white. Those shown in purple may be used for replacement.

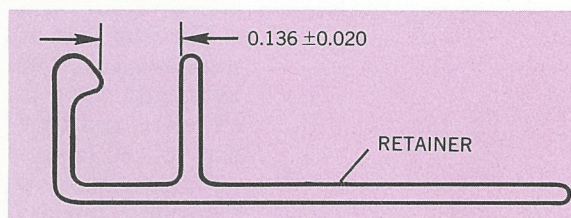
Too, pulling loose of the seals may possibly be caused by a deformed retainer. Operators may fabricate a go-no-go gage to check width of the retainer. Correct width is shown in the sketch.

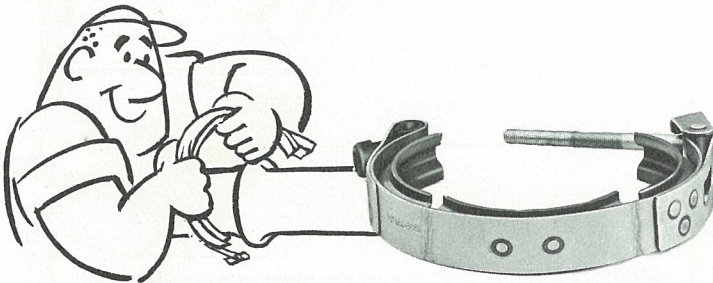
This is what happens when the coupling is over-spread. The band gets kinked and the spotwelds are weakened. Don't use a coupling in this condition.

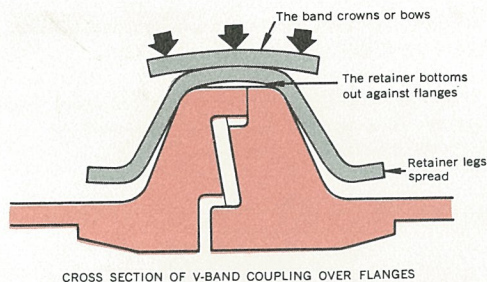
This is what happens when a coupling is overtorqued.

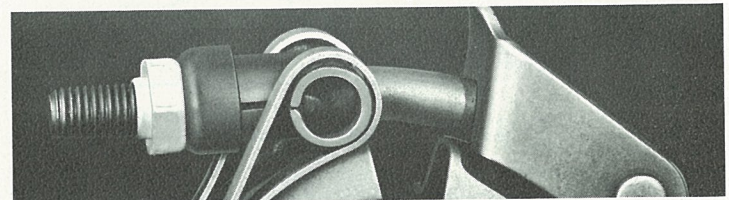
Here's an overtorqued T-bolt

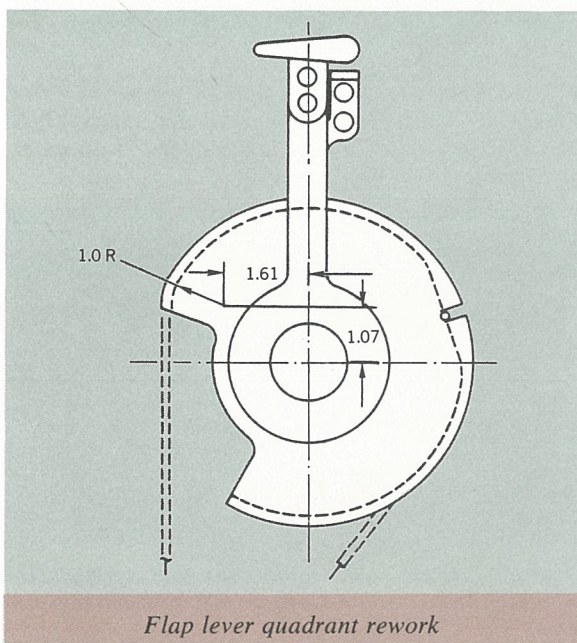
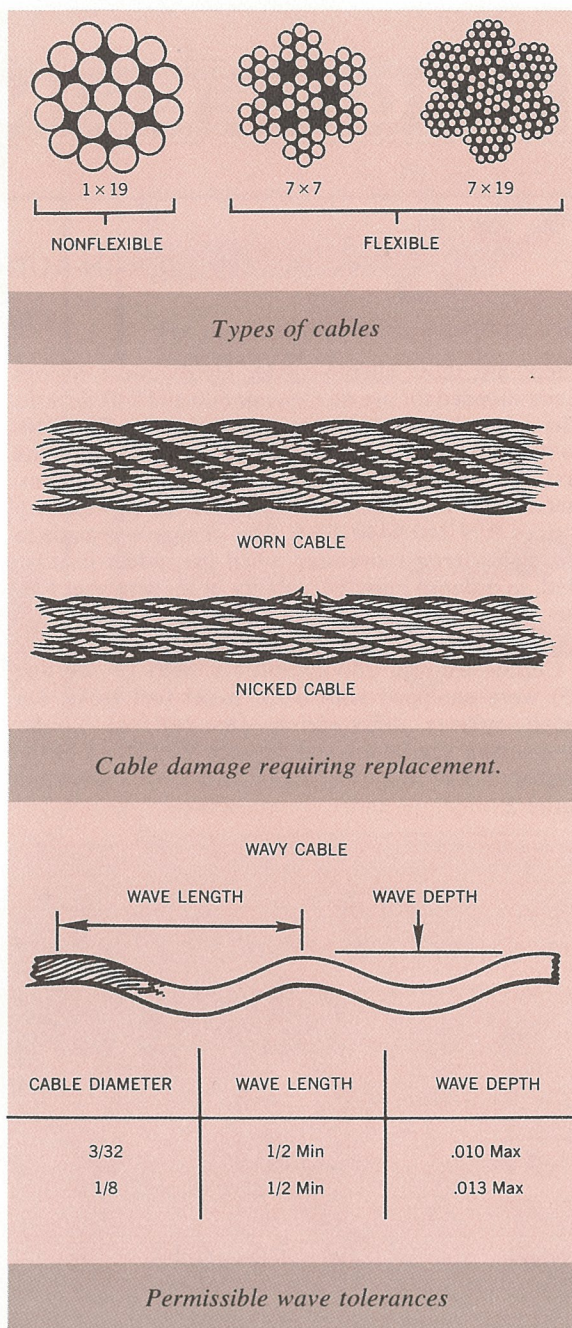
A Convair 990 operator has reported finding frayed wing flap control cables in the area of the flap handle quadrant cutout. This condition is caused by the cable pulling over the edge of the cutout in the quadrant when the handle is in the "Flaps up" position. Fatigue life of these cables can be increased by adding a one-inch radius to the quadrant, as shown in the sketch. Another means of eliminating the sharp bend would be to either relocate the lower pulley, or to splice in a section to replace the cutaway portion of the quadrant.
